# GRAYDAZE CONTRACTING

## ALKALI BURN AND SAPONIFICATION REPAIRS

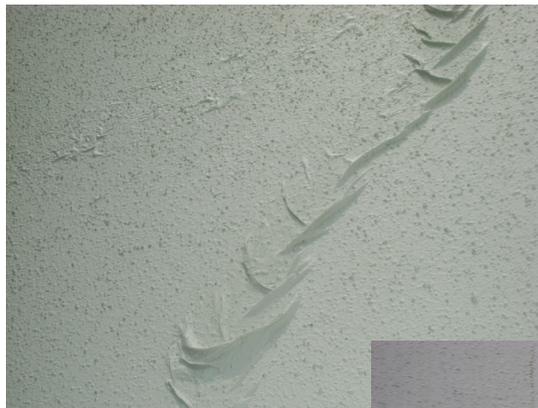
### Existing Problem

**Existing Problem:** When it rains my building has what appear to be large water bubbles in the coating. If I puncture one; water runs out, after a few days the coating will “lie down”, but in some areas it is sagging and feels brittle to the touch.

- Bubbles appear after a rain.
- White spots or folded “clouds” appear on the paint film.
- Coating delamination.

**The Solution:** The building has high Ph, and Saponification has occurred beneath the coating. The reaction has been severe enough to cause the coating to lift and retain water behind the film. Even though the coating may “lie down” after the water evaporates, the adhesion is gone and the coating will not perform as it should. The coating will need to be removed, and Ph tests performed to determine the alkalinity of the concrete. If the Ph is still high, an alkaline resistant primer will be necessary. After cleaning the area and installing the alkaline resistant primer an acrylic topcoat is recommended to help retain the color fastness of the coating.
