# GRAYDAZE CONTRACTING

## ALKALI BURN AND SAPONIFICATION REPAIRS

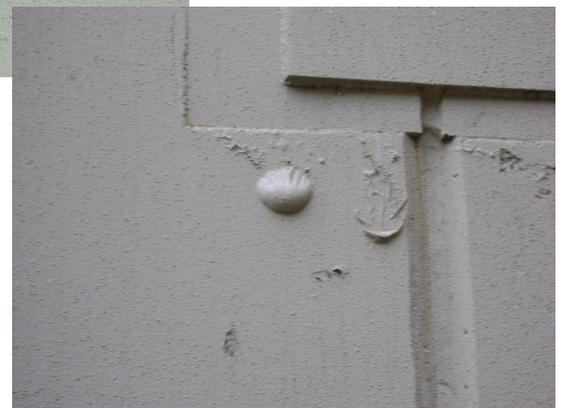
### Existing Problem

- Bubbles appear after a rain.
- White spots or folded “clouds” appear on the paint film.
- Coating delamination.

**The Solution:** The building has high Ph, and Saponification has occurred beneath the coating. The reaction has been severe enough to cause the coating to lift and retain water behind the film. Even though the coating may “lie down” after the water evaporates, the adhesion is gone and the coating will not perform as it should. The coating will need to be removed, and Ph tests performed to determine the alkalinity of the concrete. If the Ph is still high, an alkaline resistant primer will be necessary. After cleaning the area and installing the alkaline resistant primer an acrylic topcoat is recommended to help retain the color fastness of the coating.
