GRAYDAZE CONTRACTING

SLAB STABILIZATION

SLAB STABILIZATION REPAIR

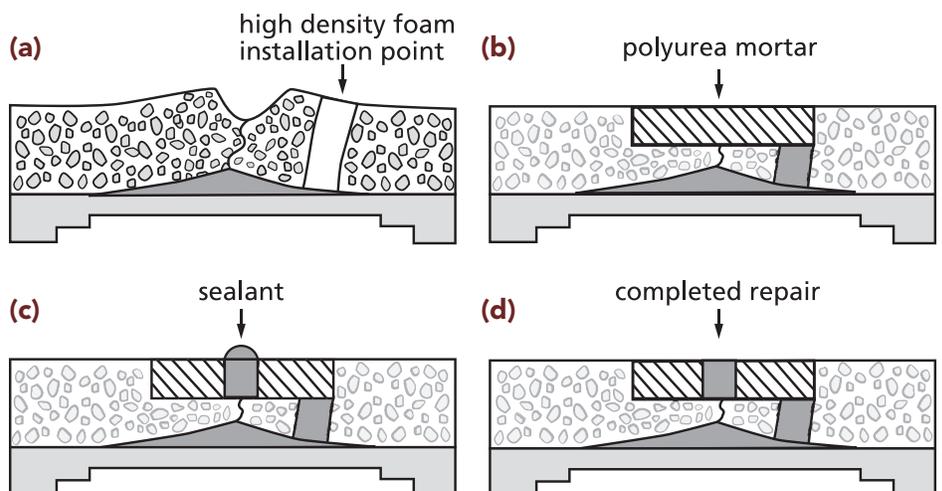
Diagram

- (a) high density chemical foam is installed to fill the void and stabilize the slab;
- (b) curled areas are ground to create a level transition;
- (c) a new joint is created to accommodate movement;
- (d) completed repair

Slab stabilization is accomplished by injecting either an expandable high density chemical foam or cementitious grout beneath the slab filling the cavity thereby stabilizing the slab. The high density foam will cure in minutes vs. days required by the cementitious grout, making the high density foam the obvious solution for an occupied facility.

The Solution: This slab has all of the classic signs of curling. The edges of the slab have actually curled upward as it cured and created a cavity or void beneath the surface. As the forklifts or other heavy machinery cross the joints the slab will roll into the cavity and the joint surfaces will collide causing the "clunk clunk" sound and damaging the shoulder. The solution is to inject expandable chemical foam beneath the slab and fill the cavity to eliminate the rocking motion. After the cavity is filled the joints can be addressed and repaired as required, (*see floor joint spall and nosing repairs*), and the transition ground smooth and flush.
